Brake Pad and Brake Disc Fault Diagnosis

Technical information

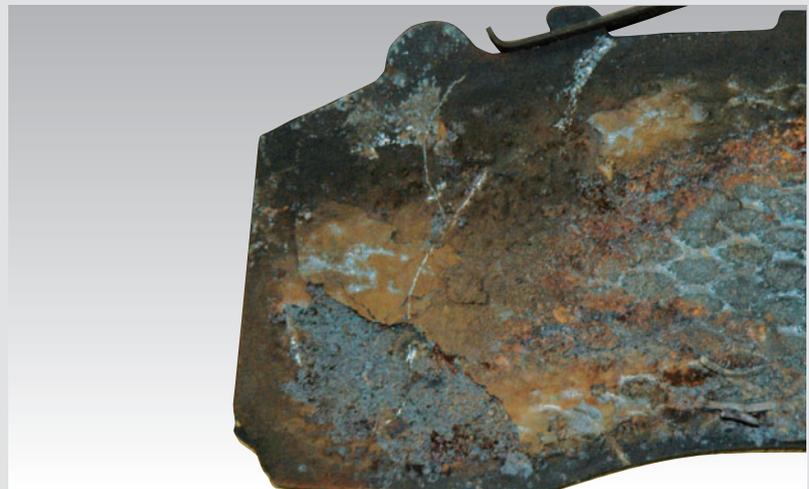
► Heavy underlying corrosion

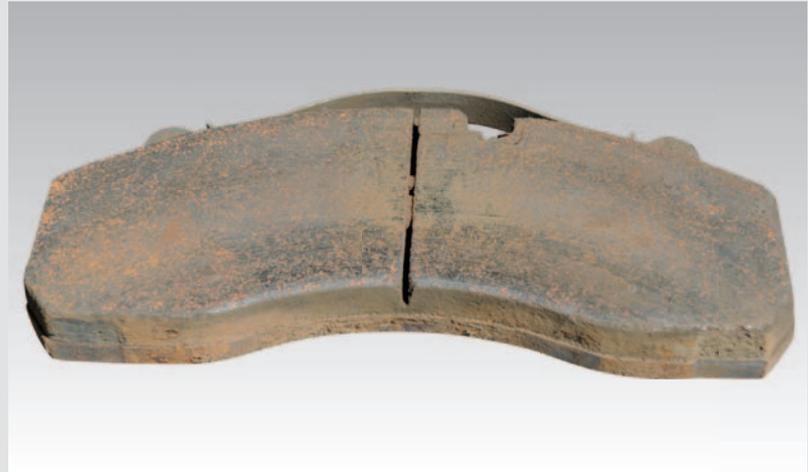
Disc brake pads have exceeded the highest permissible temperature for longer than 15–20 minutes.

During this time, constituents that contribute significantly towards stability are destroyed.

- ▶ Friction material decomposes, breaks off in some places and/or the underlayer and adhesive are damaged. Pad detaches completely; coating peels off. Partial colouring of the backing plate. Friction material has hardened, has a hard ring, reddish brown colouring of the friction material, white ash in some places.

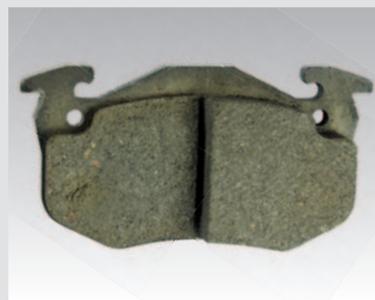
Disc brake pads have been dropped or fitted at a tilt or deformation due to extreme “wobbling” in the brake caliper.

The friction material detaches from the backing plate. Delamination occurs. Disc brake pads are new, separation above the adhesive/underlayer. Damage visible on the backing plate.

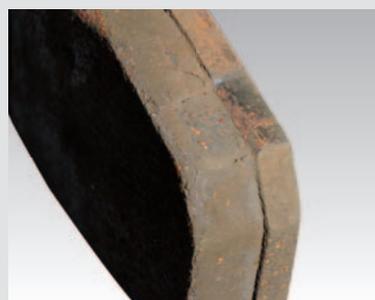
Damage as a result of bending stress visible on the backing plate.

Excessive “wobbling” of the backing plate within the brake caliper.

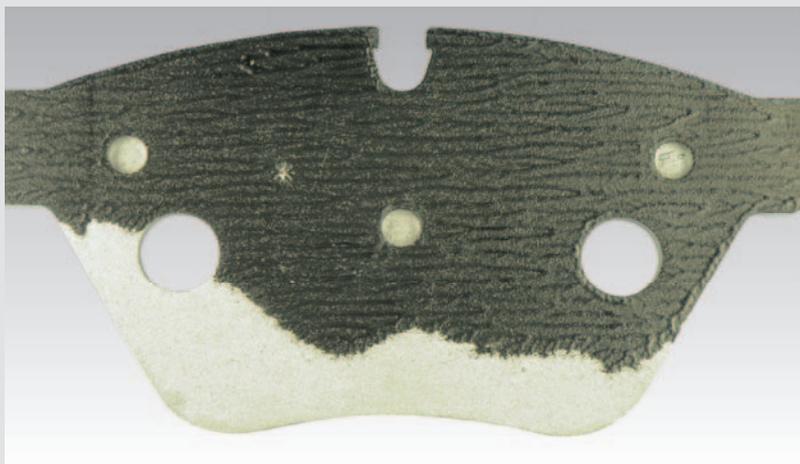
► Friction material has already become detached when subject to low stress. There is insufficient adhesive.

- Backing plate smooth or underlayer and adhesive only partially visible.
- Unsatisfactory adhesion. Underlayer improperly distributed.

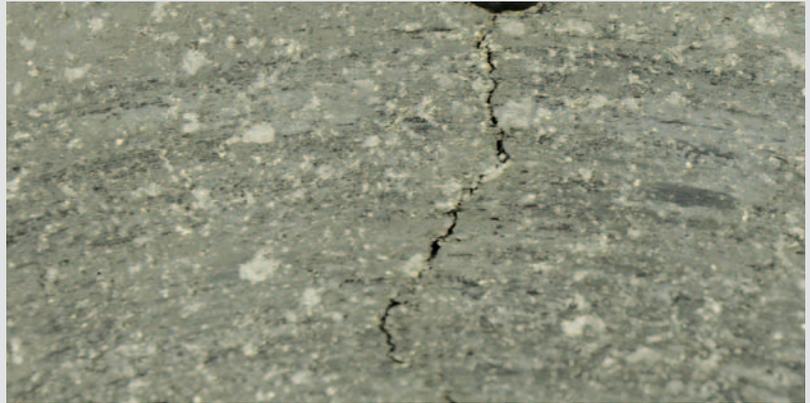
- ▶ Surface cracks can be ignored; they do not pose a safety risk. Even in the case of grooved brake pads, there is no disadvantage regarding pad stability.

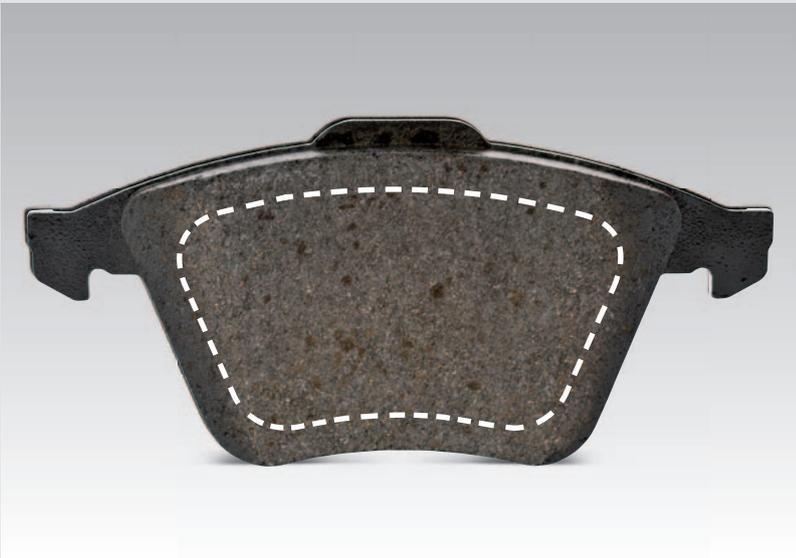
► Break-offs are permissible outside of the area marked, however, up to a maximum of 10% of the total pad surface.

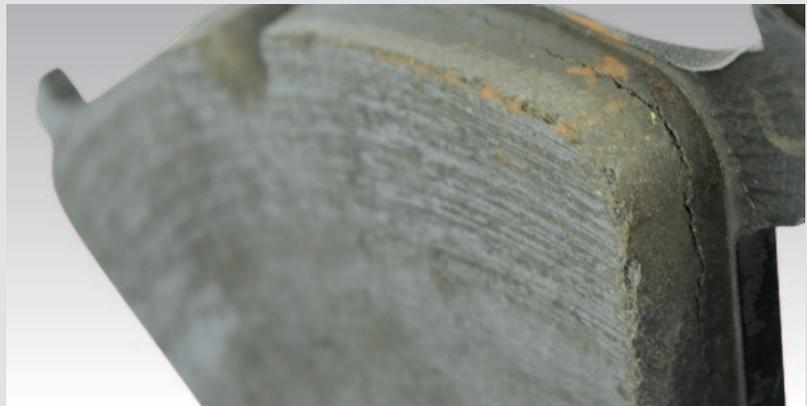
- ▶ Pad with inadmissible deterioration

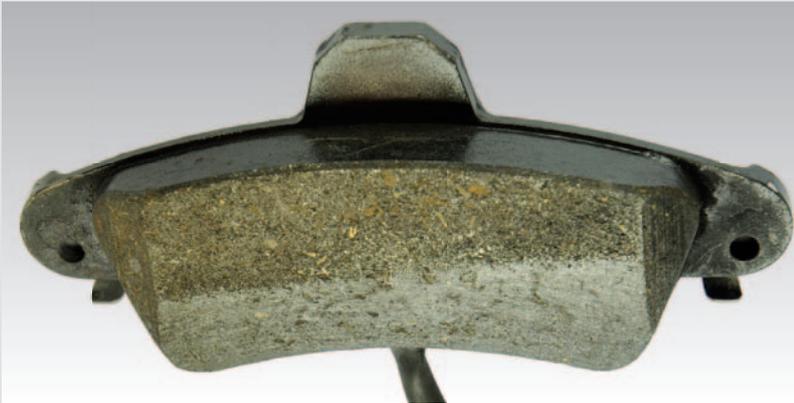
► Pad with inadequate contact pattern

- Worn or incorrect brake disc
- Brake defect/contamination
- Insufficient brake loading
- See also fitting faults/
production faults

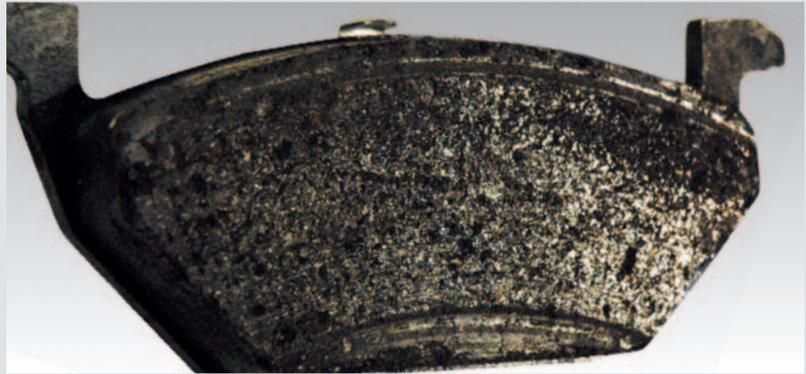
- ▶ Use of new brake pads on extremely scored/worn brake disc

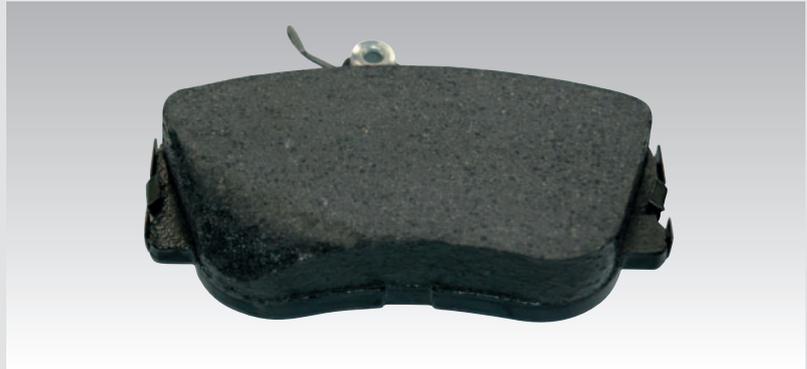
► Break-offs on the edges

Design-related pressing overhang to completely utilise the friction ring of the brake disc.

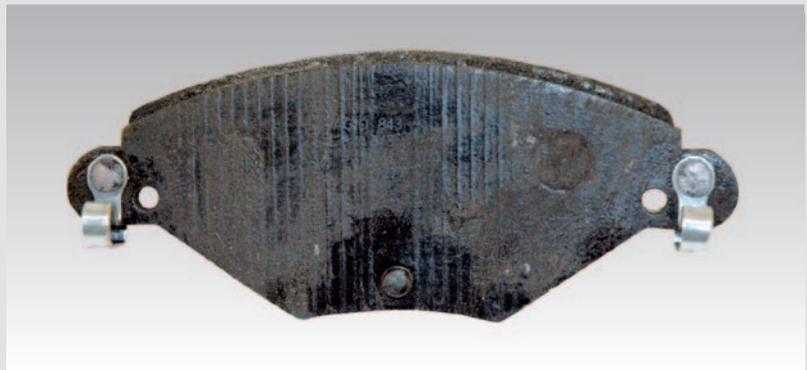
► Permissible pressing overhang

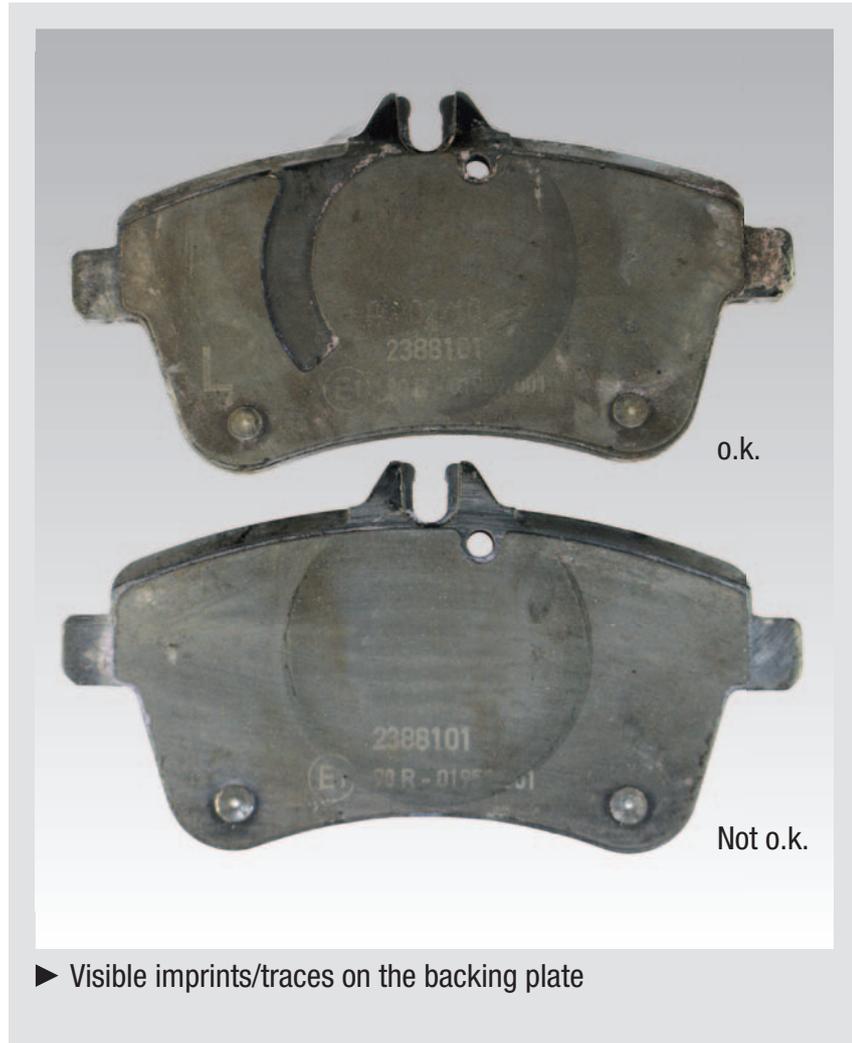
► Visible imprints/traces on the backing plate

Incorrect fitting position

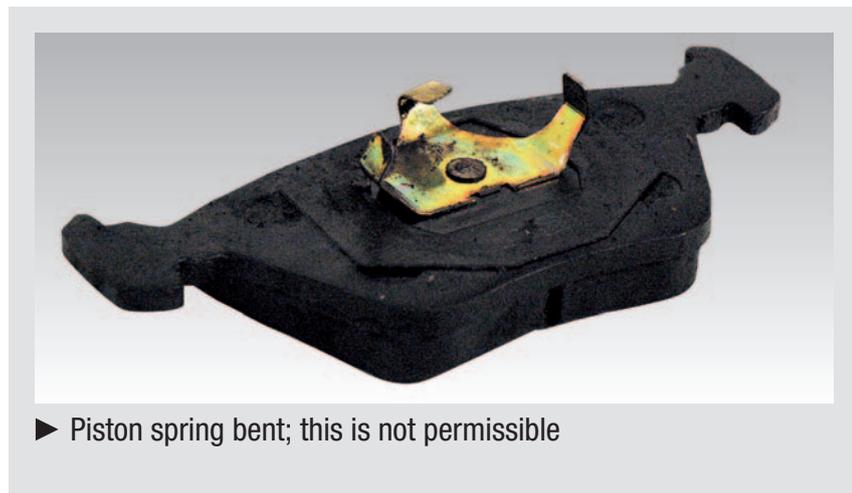
► Piston spring bent; this is not permissible

Improper handling prior to/during fitting

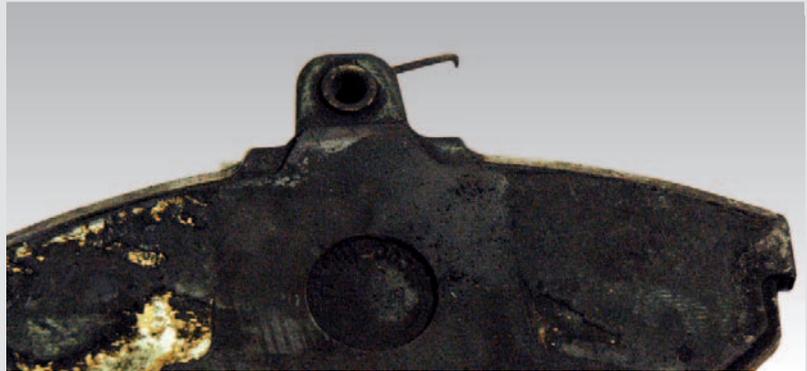
► Hold-down spring broken

The accessory is subject to use-related wear and, depending on the model type, is included in the scope of supply.

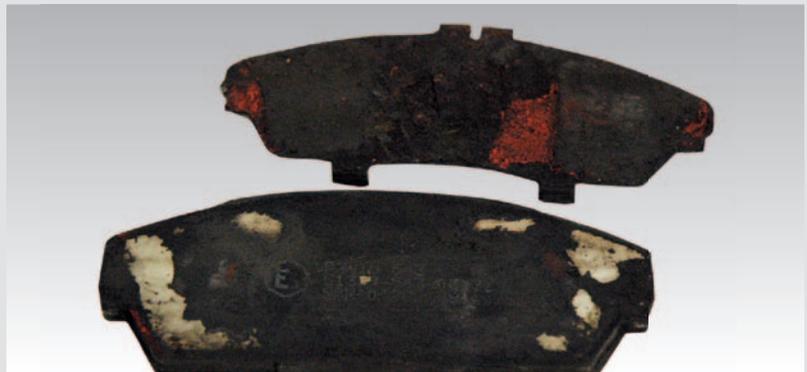
► Clip-on plates worn

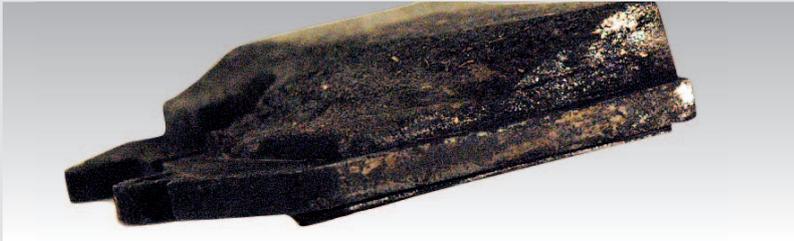
► Obvious damage due to external influence

Brake caliper not freed from contamination and corrosion.
Dimensional deviation of backing plate.

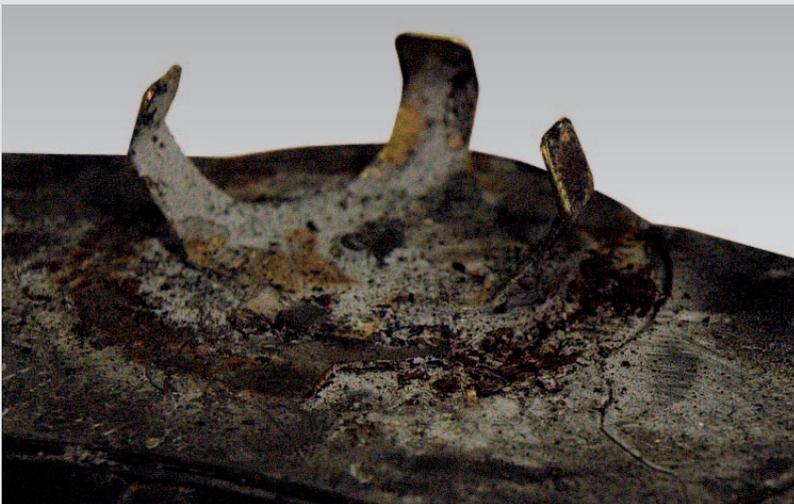
► Cut-out in the damping plate is not functioning due to contamination

Brake caliper not freed from contamination and corrosion;
excessive greasing.

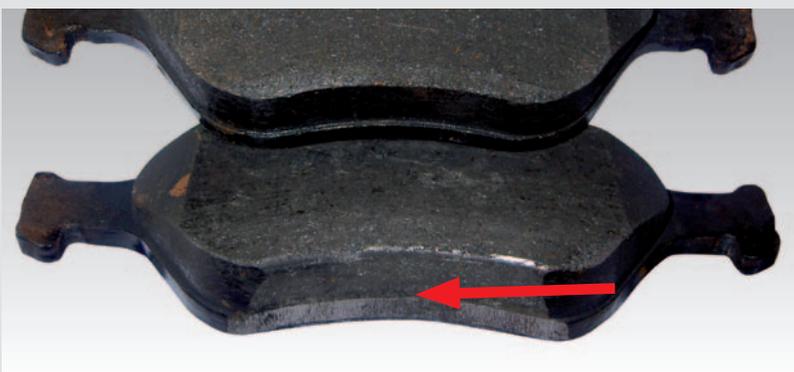
► Improperly changed pad geometry

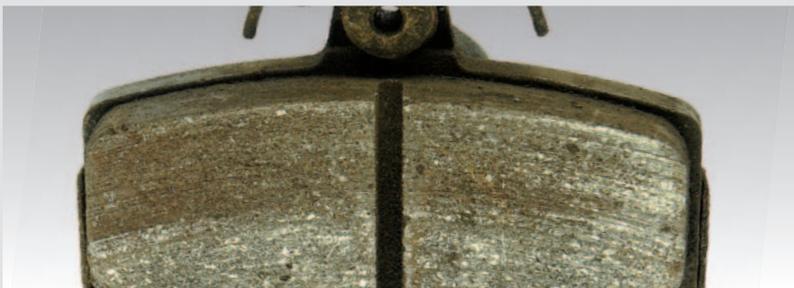
▶ Contamination of the friction surface

The operating temperature is often not reached; self-cleaning does not take place. Contamination of the friction surface by, e.g., corrosion, dirt, paint or salt.

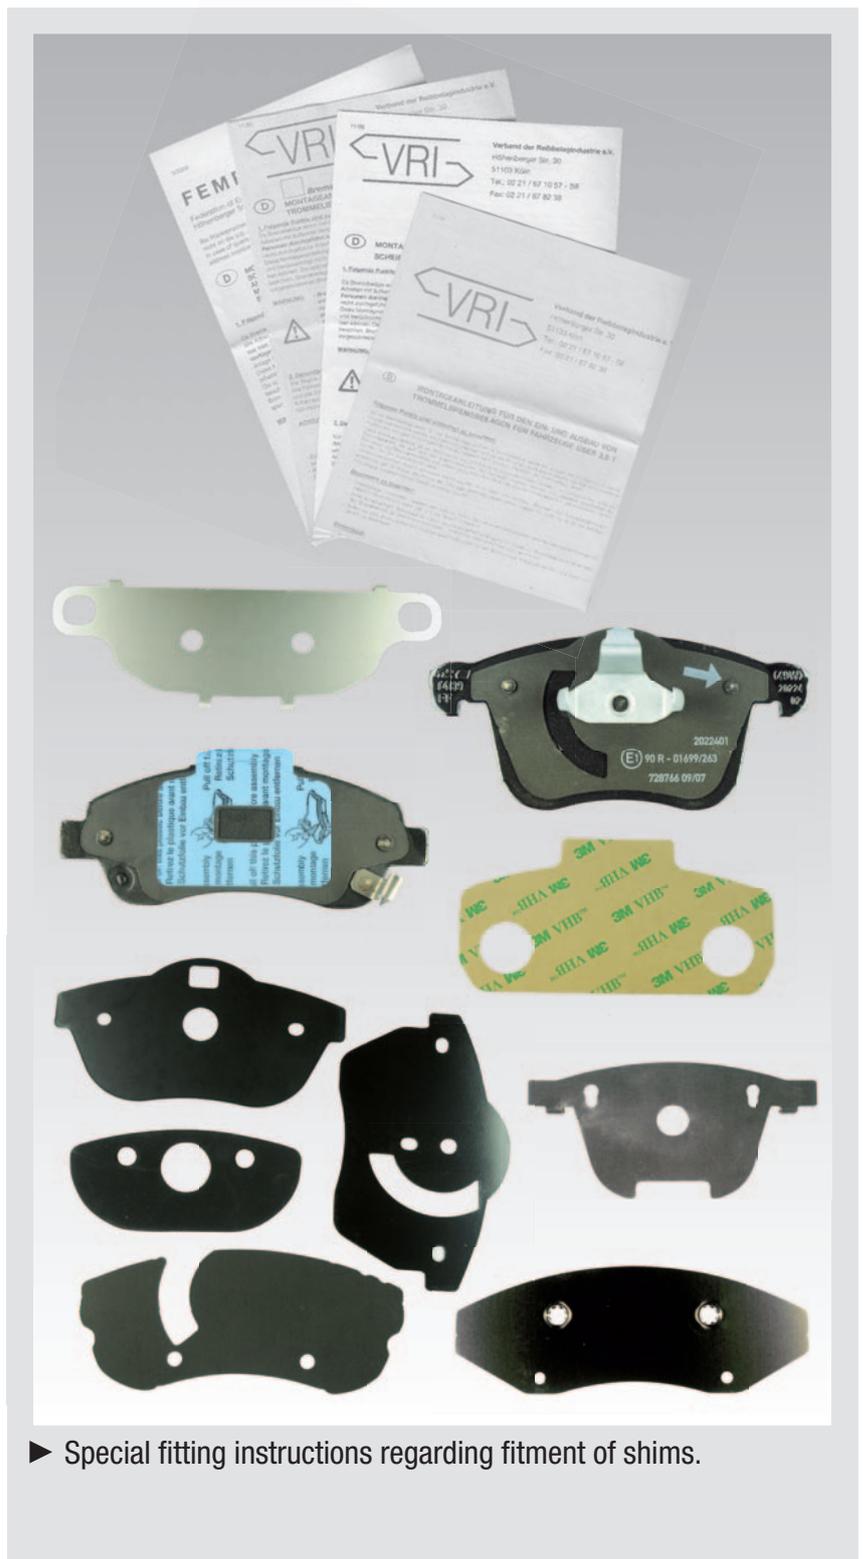
Special fitting instructions regarding fitment of noise reducing components e.g. shims must be followed to prevent noise, judder, disc cracks as well as uneven wear.

► Special fitting instructions regarding fitment of shims.

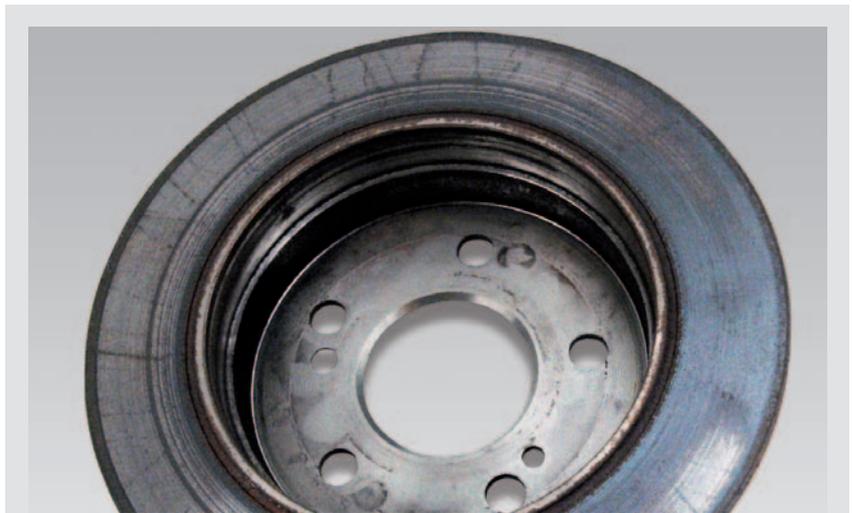
Corrosion, caused by humidity, salt or other environmental factors.

► Brake disc with static spots

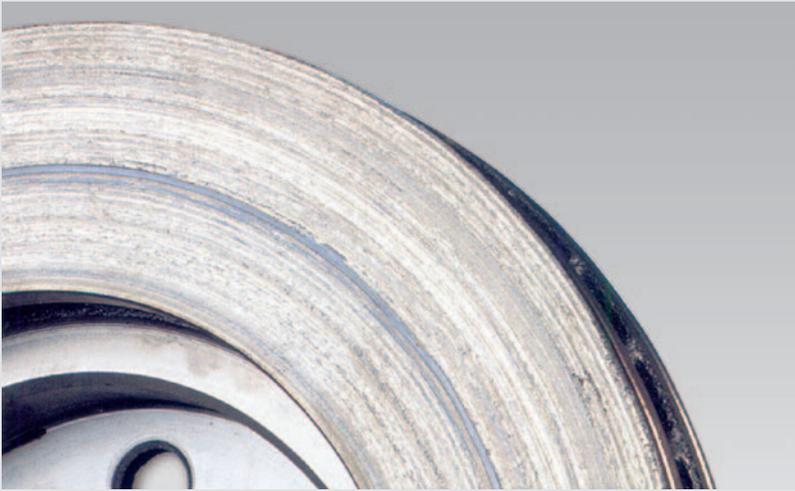
► Brake disc with score marks

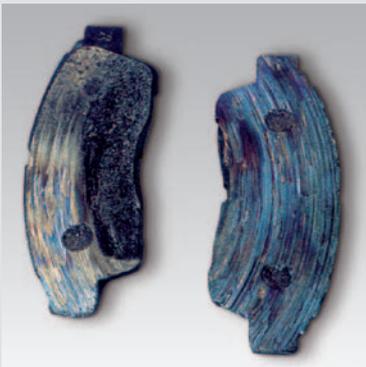
► Friction material worn down to the steel back plate

Brake pads not replaced in time.

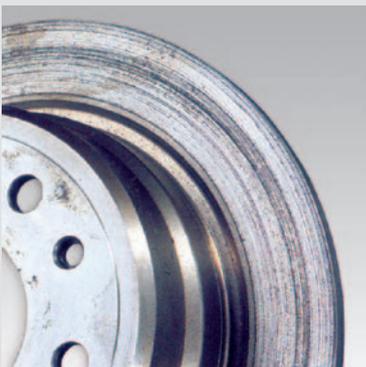
► Brake discs damaged by contact with backplate due to worn out friction material

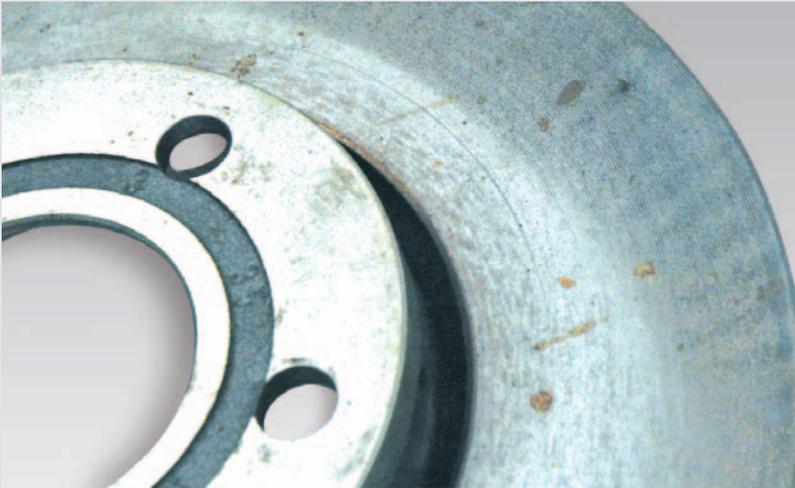
► Disc thickness variation

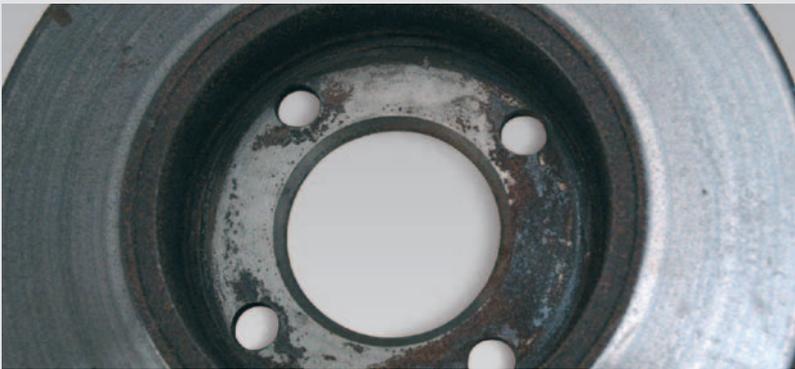
Heavy underlying corrosion at the contact surface

Insufficient cleaning, insufficient contact due to contamination.

Causes disc thickness variations as a result of unacceptable radial run-out.

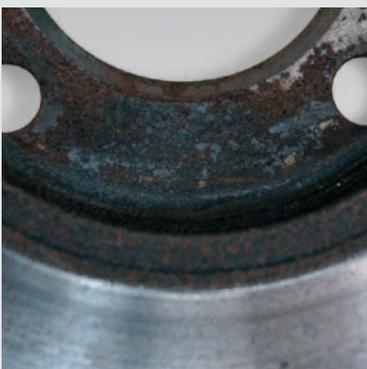
► Heavy underlying corrosion
